National Dam Safety Program. F. Houston
McIlvain Dam (Marsh Creek Dam) (National
I.D. Number 00626), Delaware River Basin,
Marsh Creek, Chester County, Pennsylvania
Phase I Inspection Report.

F. HOUSTON McILVAIN DAM (MARSH CREEK DAM)
CHESTER COUNTY, PENNSYLVANIA
NATIONAL I.D. NO. PA 00626

PHASE I INSPECTION REPORT
NATIONAL DAM SAFETY PROGRAM

May 1978

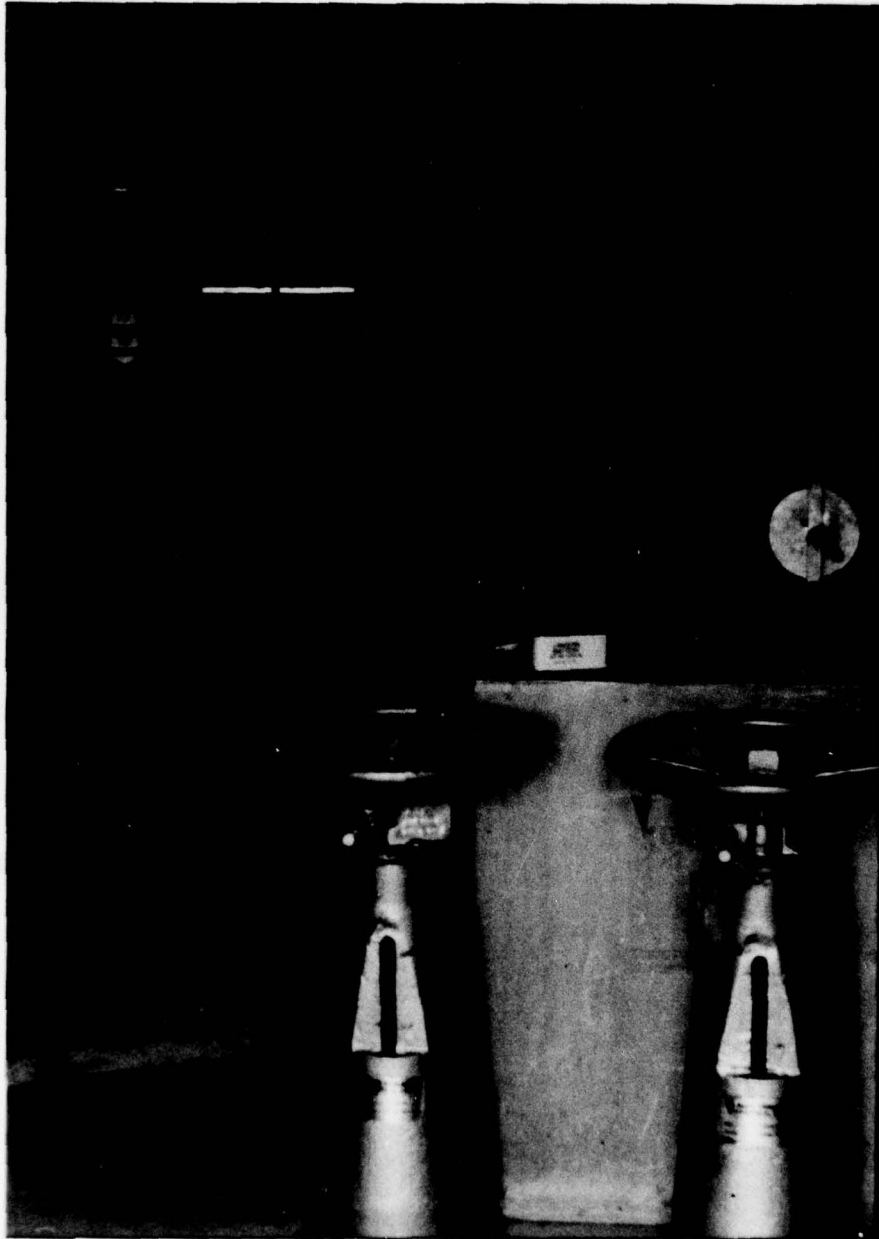
PHOTO NO. 4

VIEW INSIDE CONTROL TOWER AT THE CREST ELEVATION
SHOWING INTAKE CONTROL VALVES AND THE USGS GAGE STATION.
